SMITHSONIAN INSTITUTION
BUREAU OF AMERICAN ETHNOLOGY
BULLETIN 121

ARCHEOLOGICAL REMAINS IN THE WHITEWATER DISTRICT EASTERN ARIZONA

PART I. HOUSE TYPES

By FRANK H. H. ROBERTS, JR.

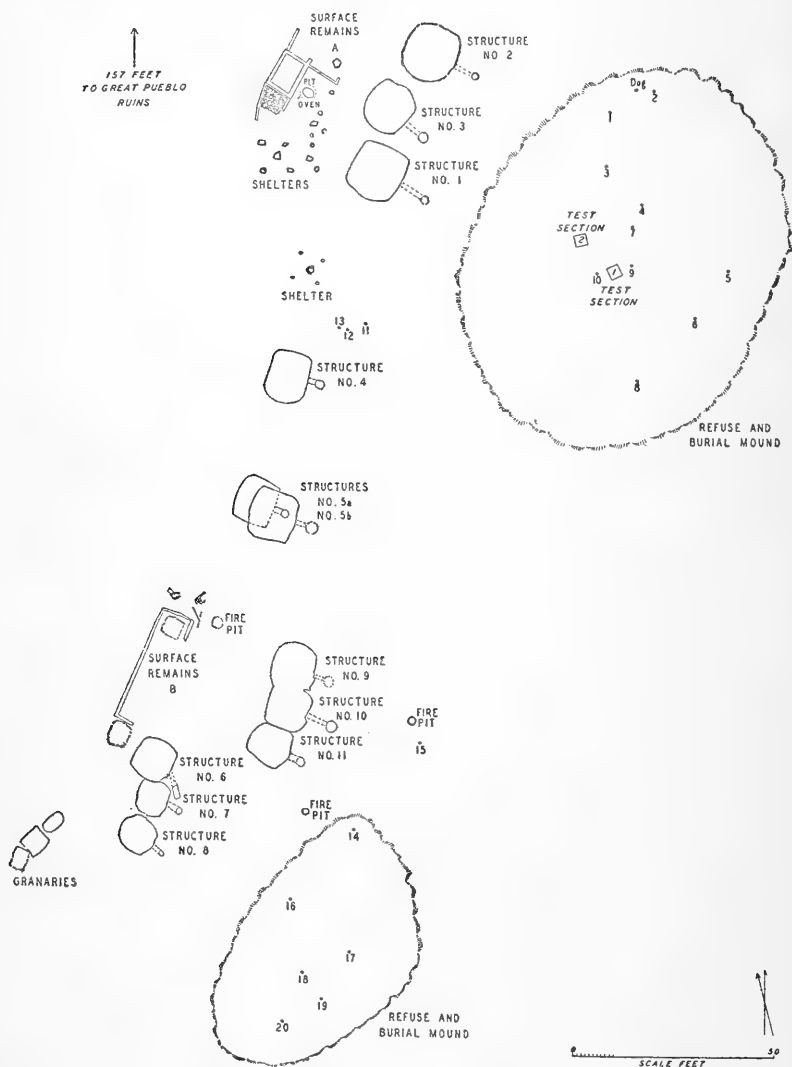
FIGURE 1.—Group 1 pit and surface remains. Numbered dots indicate location of burials.

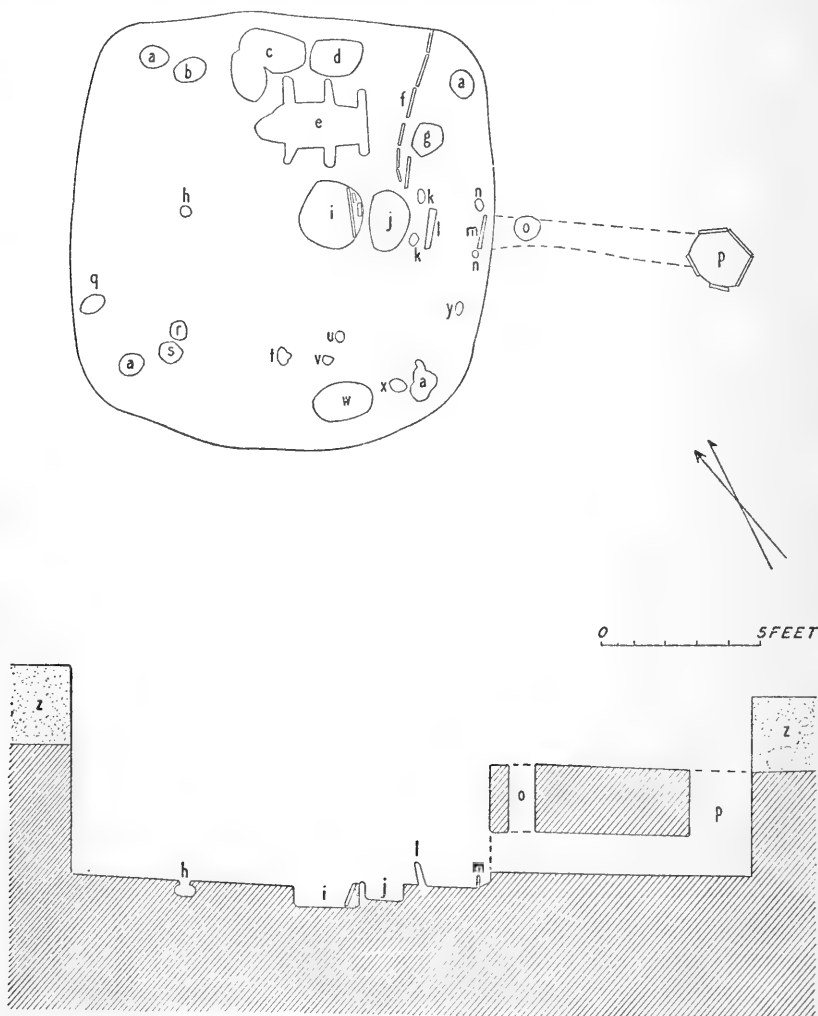
FIGURE 2.—Structure 1. *a*, holes for support posts; *b*, *c*, and *d*, storage basins; *e*, basin in floor; *f*, wall forming compartment; *g*, basin in floor; *h*, sipapu; *i*, fire pit; *j*, ash pit; *k*, ends of ladder poles; *l*, deflector; *m*, stone to protect ventilator opening; *n*, pole placement; *o*, small shaft in ventilator; *p*, main ventilator shaft; *q*, pot rest or storage hole; *r*, *s*, *t*, *u*, *v*, *w*, *x*, and *y*, storage holes and basin; *z*, sand accumulation above old ground level.

The larger basin-like depressions (fig. 2, *c*, *d*, *w*) possibly served as places in which baskets or jars were set, although there was no indication that such had been the case. What function the curiously shaped depression *e* may have been intended to fulfill is a question for which no answer has been found. At the time when the remains were excavated a small pitcher of the culinary variety of pottery was sitting in the end toward the ventilator side of the room. Several who saw the house suggested that loom sticks may have been placed across the depression in the arm-like projections at each side of the central portion. In view of weaving practices in general, as they are known throughout the Southwest, this does not seem to be a good explanation. There was nothing about the depression itself to furnish a clue.

The hole marked *h*, figure 2, corresponds in its general size and position to similar ones found in most pit houses and in many present-day kivas. In the kivas or ceremonial chambers the feature is called the sipapu, because the modern Pueblos use that name or a close variation of it to designate the hole. According to them it symbolizes the mythical place of emergence through which their ancestors are supposed to have passed in their journey from the inner portions of the earth, where they were created, to the surface of the world upon which they now live. Whether a similar interpretation was made in the past or not is a matter of conjecture. The belief is so firmly implanted in Pueblo mythology, however, that it may with considerable justification be assumed that the prehistoric people regarded the feature in the same light. A further support for this theory is derived from

At the base of the ladder an upright stone was set in the floor midway between the fire pit and the ventilator opening in the wall (fig.

seven stones forming a bin-like enclosure at the southeast corner of the room (fig. 2, *f*; pl. 3, *a*). One of the typical interior elements in Modified Basket Maker houses consists of a low wall of stone slabs separating the ventilator or, as was the case in many of the dwellings of that period, the entrance side of the chamber from the rest of the room. Sometimes the partition wall extended entirely across from support post to support post. Then again it was broken by a doorway in front of the passage opening into the wall. Occasionally a house is found that only has corner bins at that side of the room.²⁰ The enclosure in one corner of No. 1 is very suggestive of the more complete examples found in the Chaco Canyon houses and possibly represents a survival in the houses of a later day of a characteristic common during a previous stage in house development. The purpose of such compartments is not known. Two metates or grinding stones were found in the present example. This would suggest that the enclosure may have served as a mealing bin for the house. On the other hand it is quite possible that the stones were placed there during intervals when they were not in use, since one was leaning against the partition and the other against the wall. The bin may have served solely in the capacity of a storage place. Firewood, jars containing surplus food and other items connected with the daily life of the people could have been placed there where they would not interfere with the general trend of affairs in the main part of the structure. Somewhat comparable enclosures in the earth lodges of some of the Plains Indians, dwellings which in many ways bear a strong resemblance to the pit houses of the Southwest, despite the fact that they were largely surface structures, were employed for storing the supply of firewood in winter.²¹

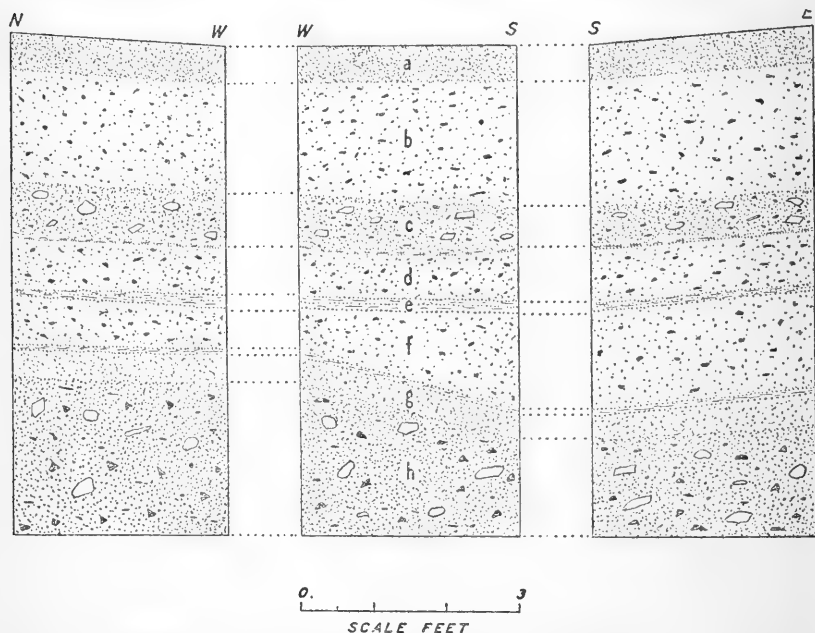
FIGURE 3.—Pillar left from fill in structure 1. N, W, S, and E, indicate north, west, south, and east corners. *a* to *h*, Strata in fill.

The second stratum (fig. 3, *b*) was considerably thicker than the first. It was 1 foot 6 inches (45.72 cm) from top to bottom. The main content was blow sand and ashes with some charcoal. Toward the lower half there was a marked increase in the number of potsherds present. In fact there was only one other layer in the entire pillar which contained more. This would suggest that there was considerable activity around the site at that time and the remains of many broken vessels found their way into the abandoned pit. The stratum did not give distinct evidence at this point of having typical refuse material in it and it does not seem that it can be attributed to house sweepings and other waste matter being dumped there. Rather would the character of the fill at this point suggest a more or less natural gravitation of objects into a depression.

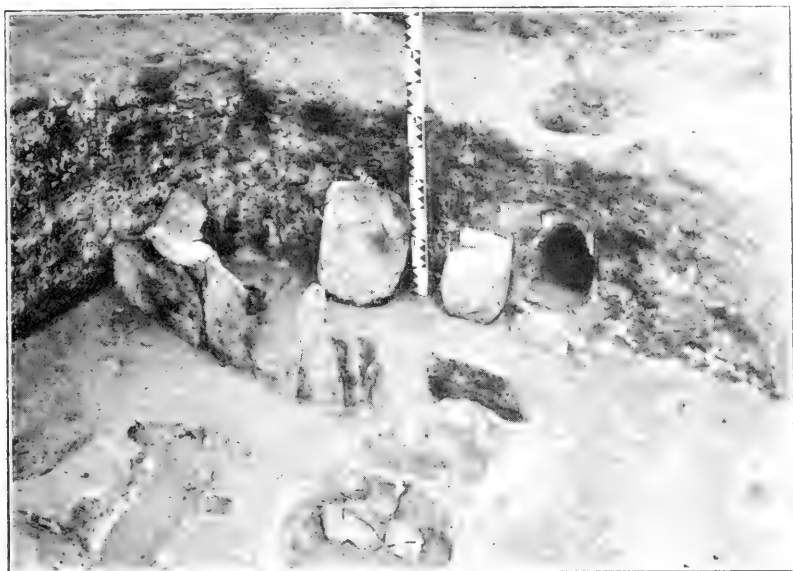
a. Interior of structure 1.

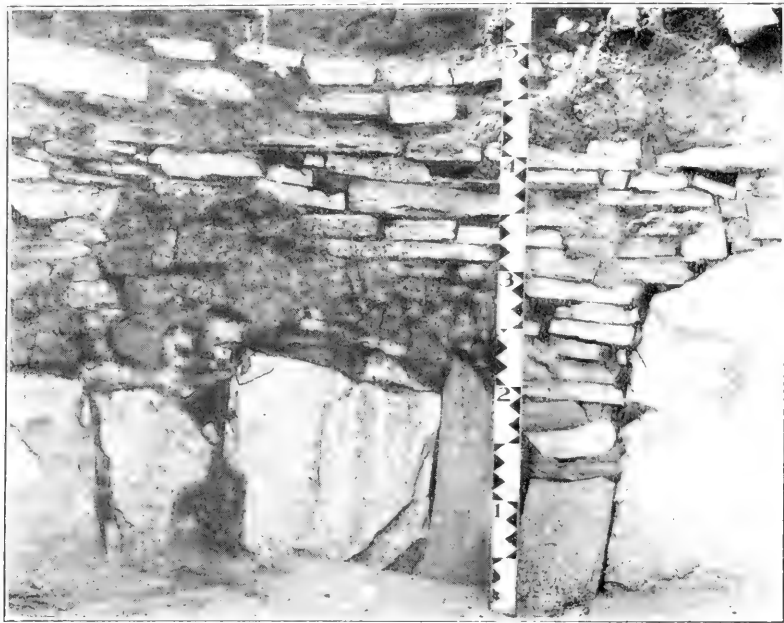
a Masonry wall resting on slab foundation.

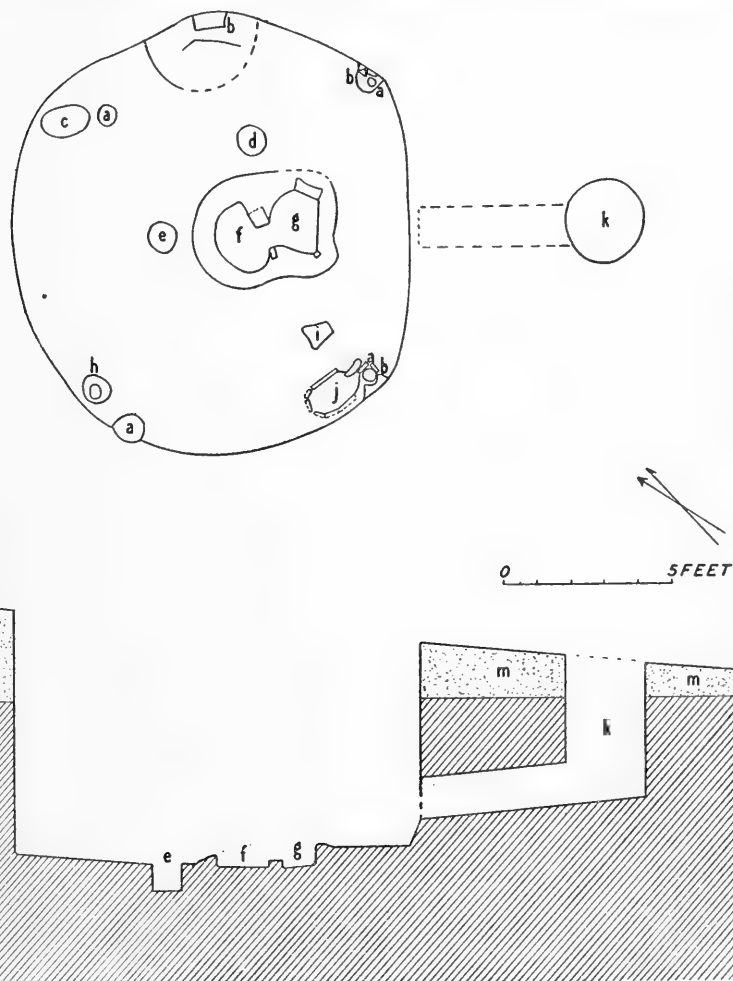
FIGURE 6.—Structure 3. *a*, support posts for superstructure; *b*, pilasters; *c*, storage basin; *d*, storage hole; *e*, sipapu; *f*, fire pit; *g*, ladder box; *h*, storage hole; *i*, stone embedded in floor; *j*, secondary fire pit; *k*, ventilator shaft; *m*, sand accumulation above old surface.

The superstructure was supported by four posts set in the floor and one pilaster or masonry pillar. Two of the support posts had been braced with mud plaster placed between them and the wall in the same fashion that the post in No. 2 had been buttressed (pl. 7, *b*). One curious factor in this connection is that in both Nos. 2

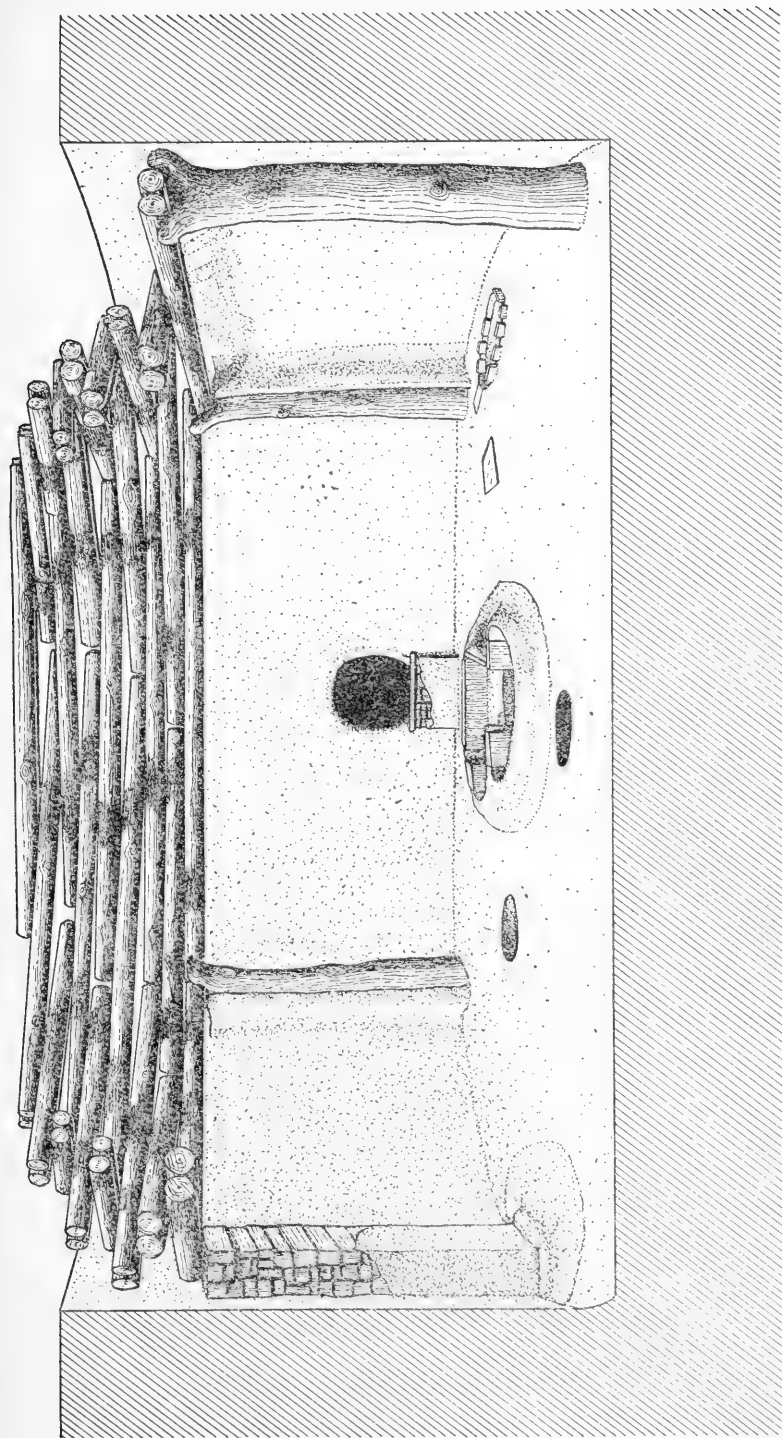
FIGURE 7.—Postulated reconstruction of cribbed roofing erected over pit of structure 3. One side removed to show method of laying timbers.

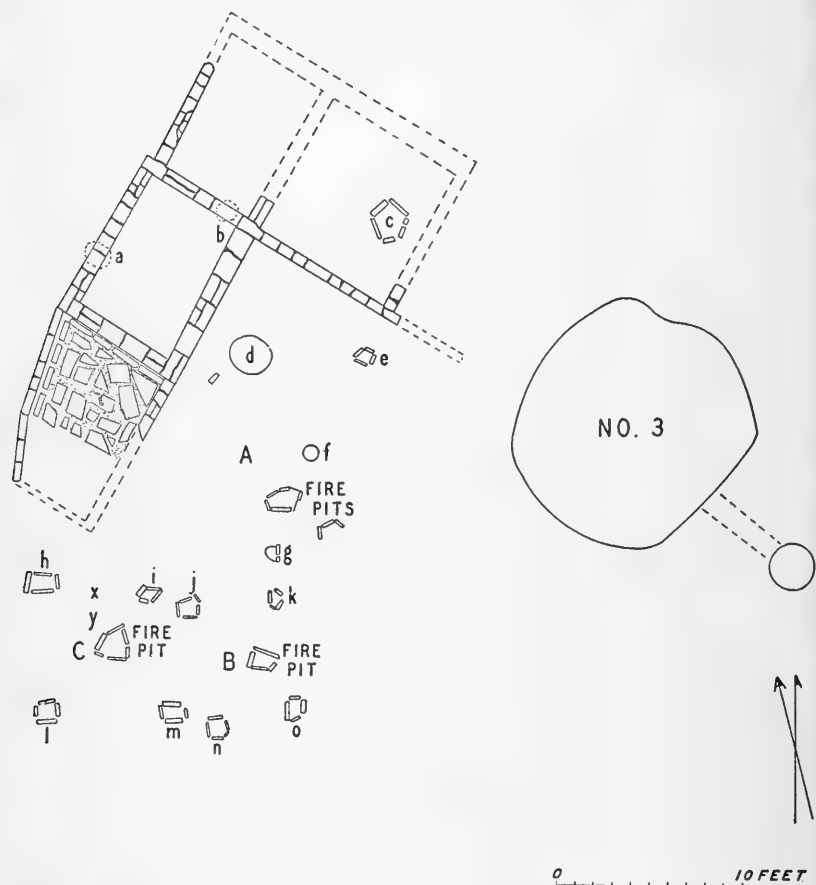
FIGURE 8.—Remains of surface building A. *a* and *b*, fire pits beneath foundations; *c*, fire pit in floor of room; *d*, opening into pit oven; *e*, *f*, and *g*, placements for portico posts; *h*, *i*, *j*, *k*, *l*, *m*, *n*, and *o*, placements for shelter posts; *x*, location of fragment of child's skull; *y*, location of black-on-white bowl.

extended across former fire pits (fig. 8, *a*, *b*). At the time the structure was built these pits were apparently on or just below the existing level of occupation. They were filled with stones and mud before the wall was carried across them (pl. 8, *a*). Another feature, that of a porch or portico, was indicated by the row of post molds or holes along the front of the structure. A similar feature was found near house 15 and inasmuch as the latter exhibited better the

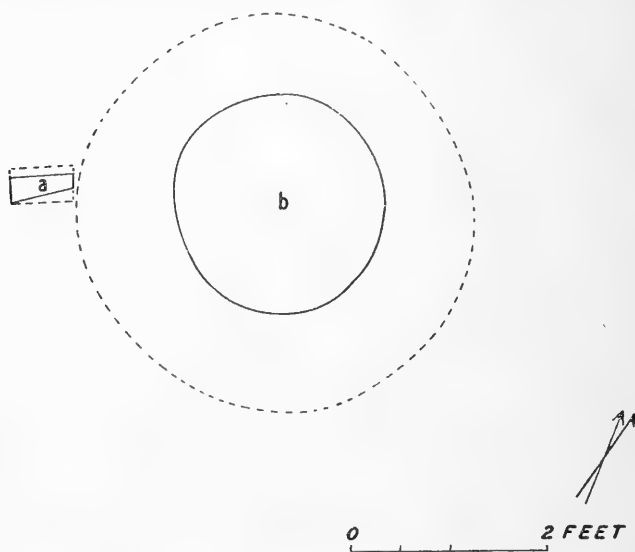
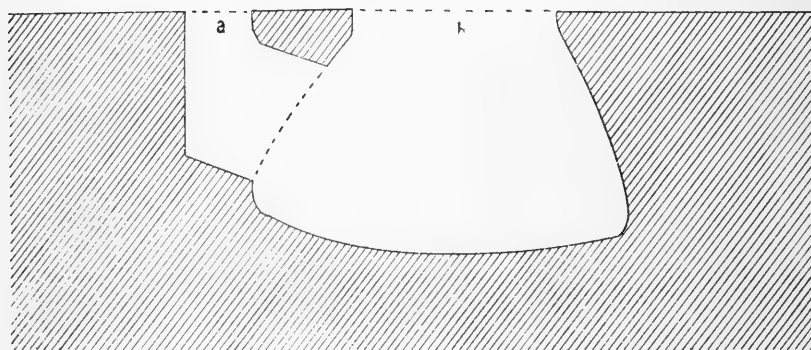
FIGURE 9.—Pit oven. *a*, flue; *b*, opening on ground level.

There was a slight difference between the example found on the Zuñi Reservation and that uncovered at this location. In the Zuñi pit the flue was oval to circular in form. It sloped obliquely upward and its outer end opened on the surface some distance from the main aperture of the oven.³² The flue of the oven in the court of Surface

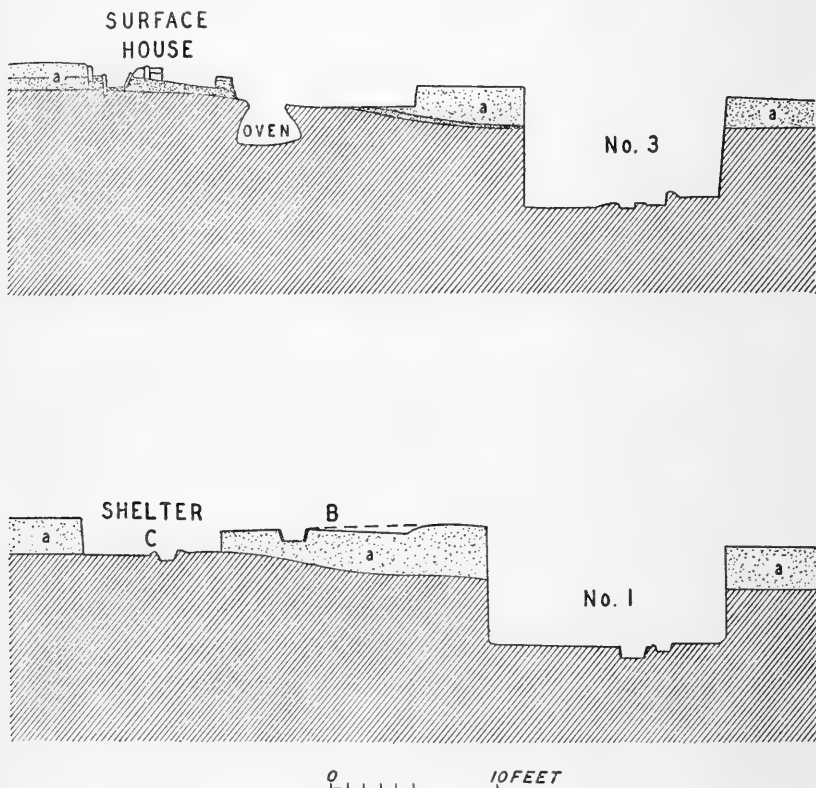
FIGURE 10.—Sections through surface remains A, pit oven and structure 3, shelter and structure 1. *a*, accumulation of sand above original surface of occupation.

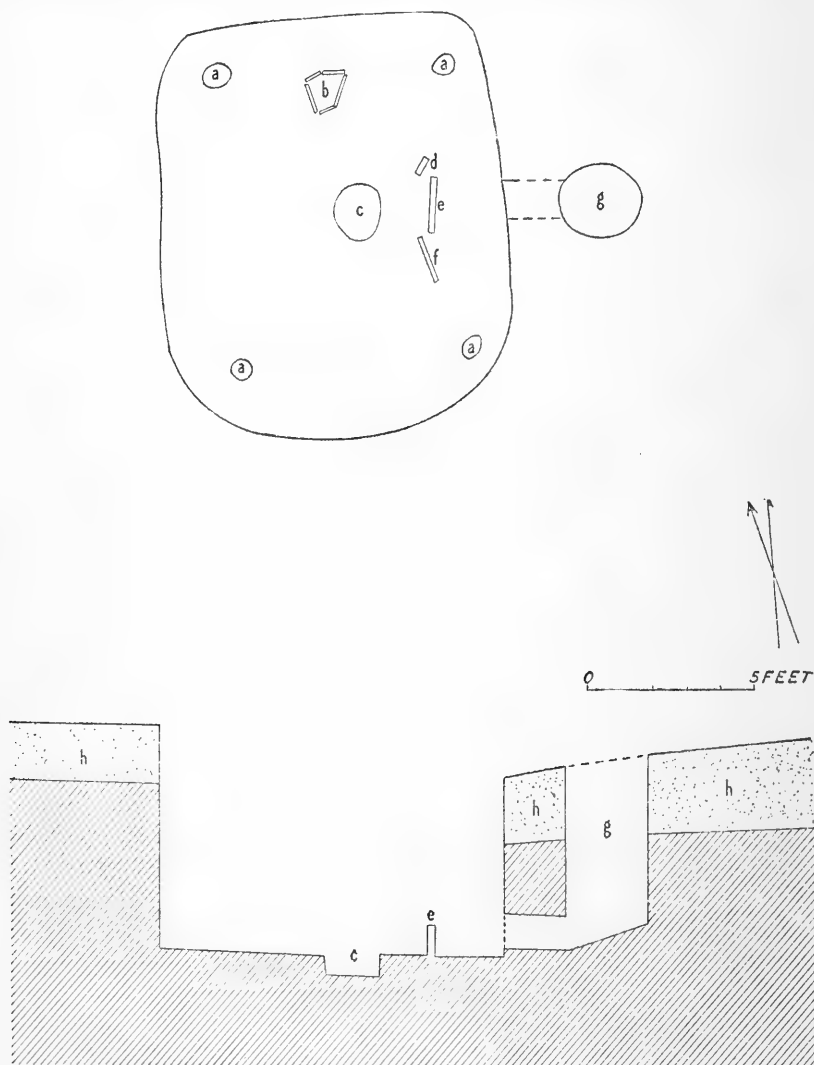
FIGURE 11.—Structure 4. *a*, holes for main support posts; *b*, storage box in floor; *c*, fire pit; *d*, standing stone; *e*, deflector; *f*, standing stone; *g*, ventilator shaft; *h*, sand accumulation above original surface.

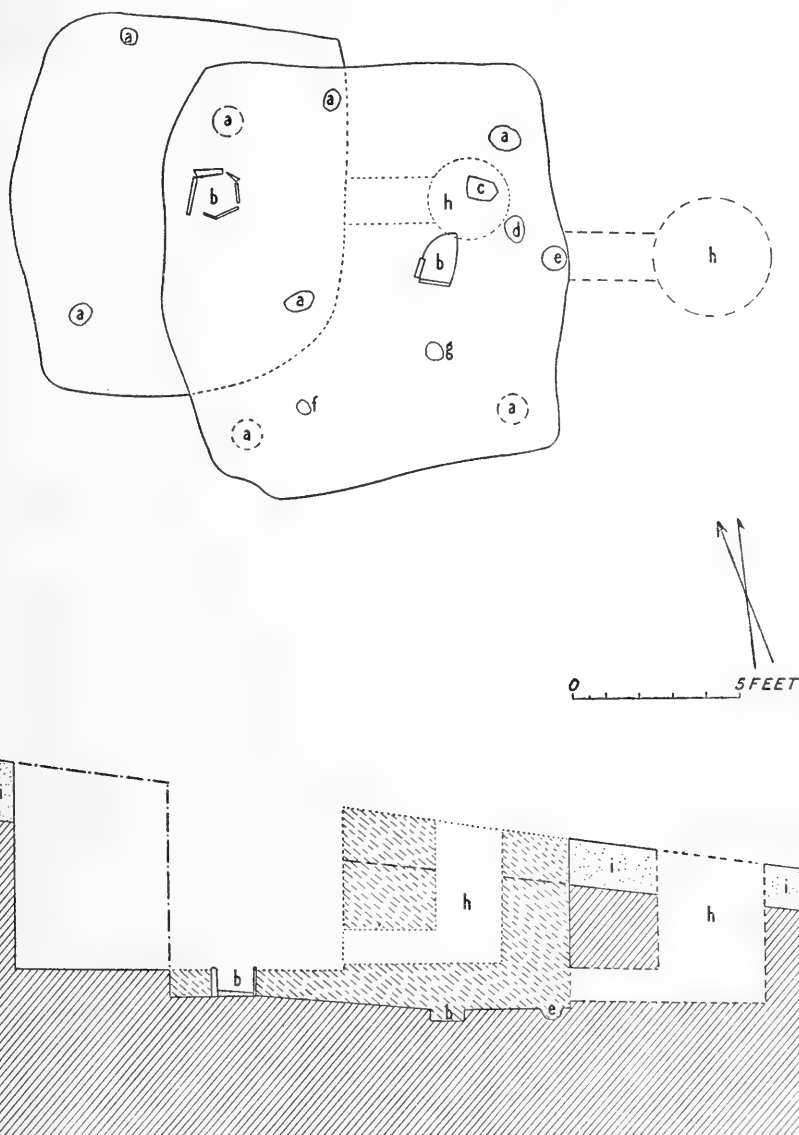
FIGURE 12.—Structures 5a and 5b. *a*, holes for main superstructure supports; *b*, fire pits; *c*, stone embedded in floor; *d*, basin in floor; *e*, hole in floor; *f* and *g*, storage holes; *h*, ventilator shaft; *i*, sand accumulation above old surface.

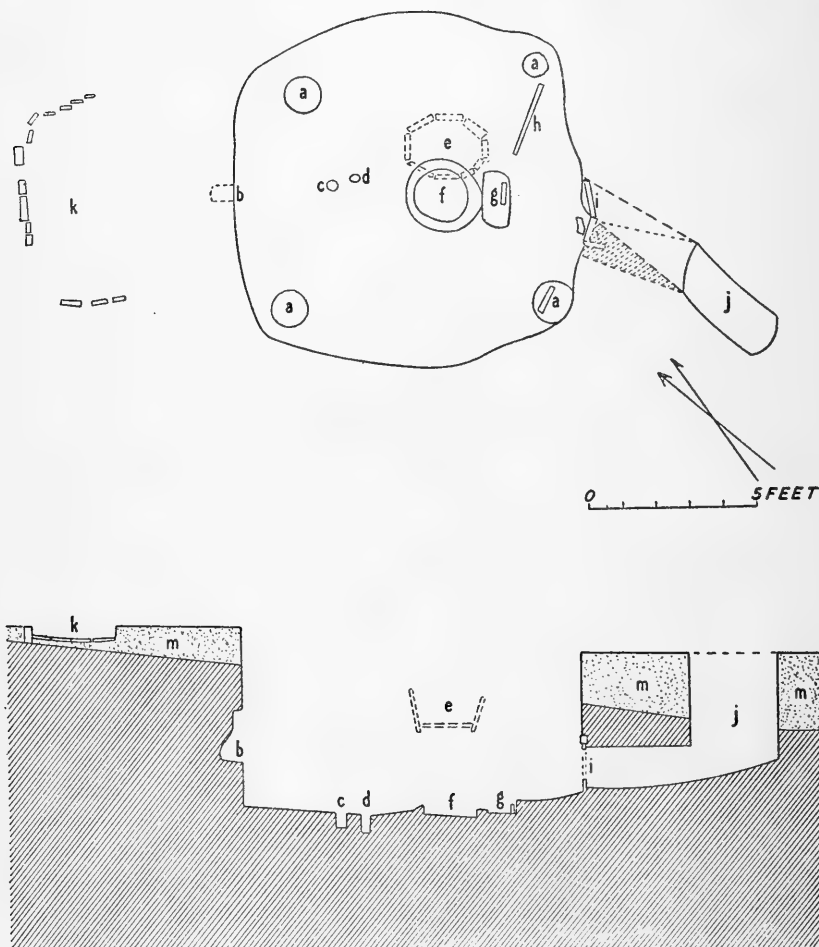
FIGURE 14.—Structure 6. *a*, holes for main roof supports; *b*, placement for roof brace; *c*, storage hole; *d*, sipapu; *e*, fire pit in fill; *f*, fire pit for 6; *g*, ladder pit; *h*, stone forming bin; *i*, ventilator stone; *j*, ventilator shaft; *k*, remains of granary; *m*, sand accumulation above old surface.

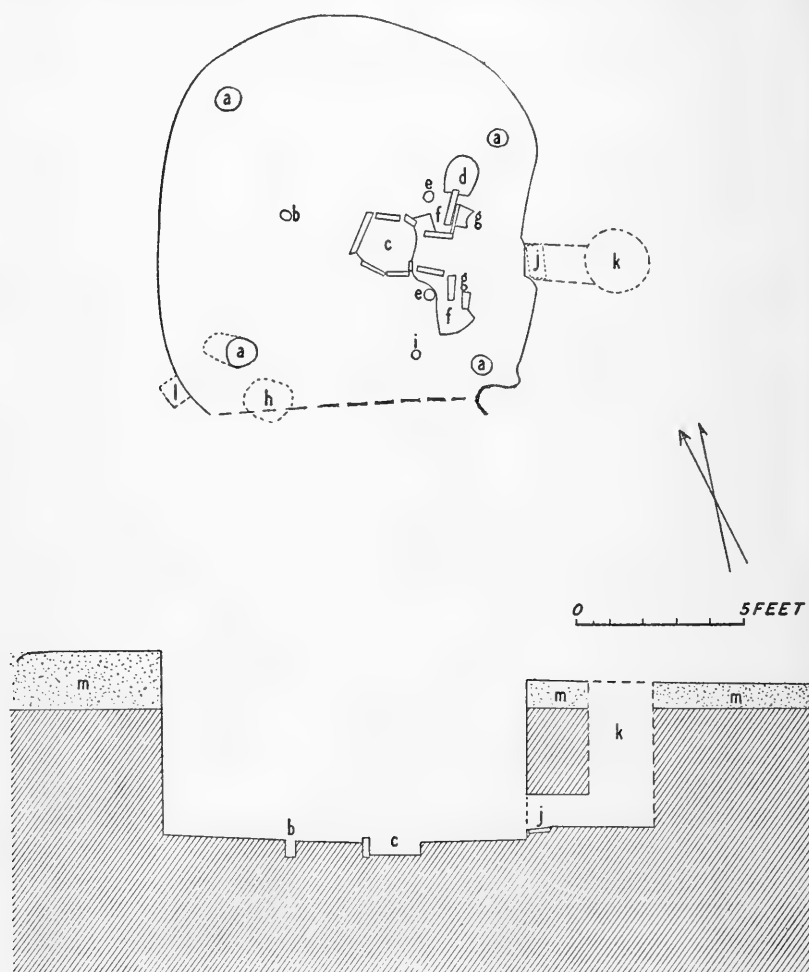
FIGURE 18.—Structure 9. *a*, holes for main support posts; *b*, sipapu; *c*, fire pit; *d*, fallen stone from compartment wall; *e*, holes for small poles; *f*, adobe plaster placement for compartment wall slabs; *g*, stones in compartment wall; *h*, location of support post for superstructure over 10; *i*, storage hole; *j*, ventilator opening and sill; *k*, ventilator shaft; *l*, placement for roof brace; *m*, sand accumulation above old surface.

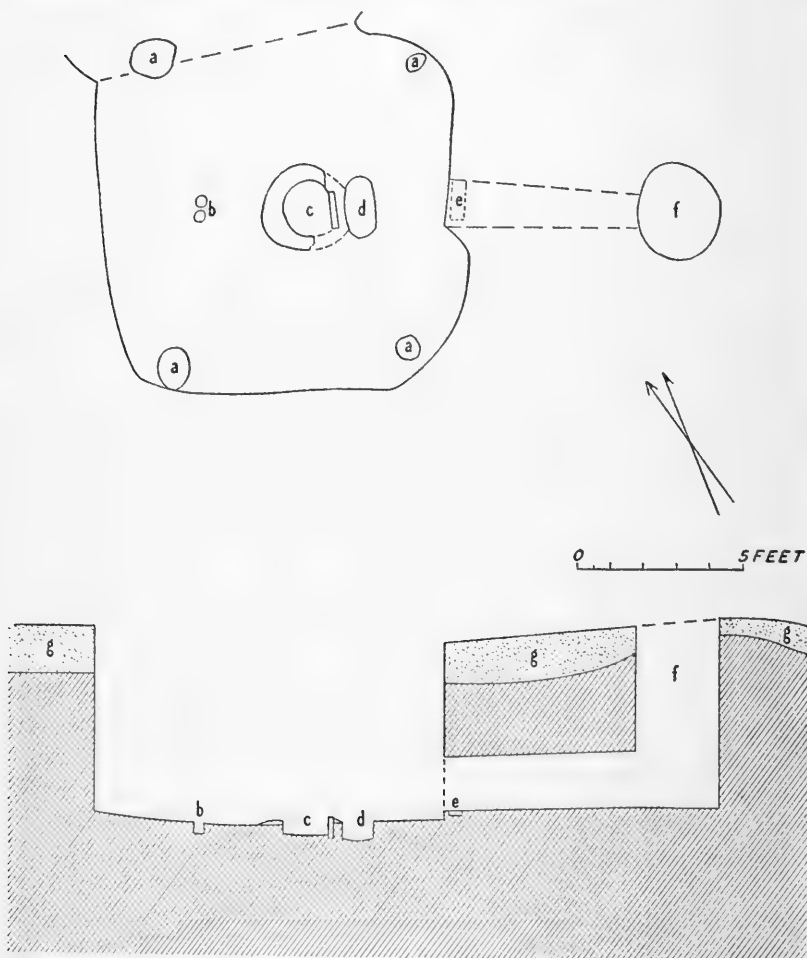
FIGURE 19.—Structure 10. *a*, holes for support posts; *b*, sipapu; *c*, fire pit; *d*, ladder box; *e*, ventilator opening; *f*, ventilator shaft; *g*, accumulation of sand above original surface.

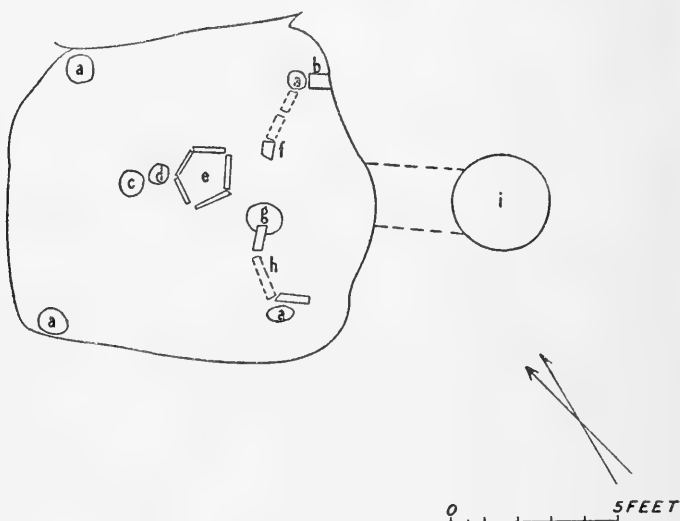
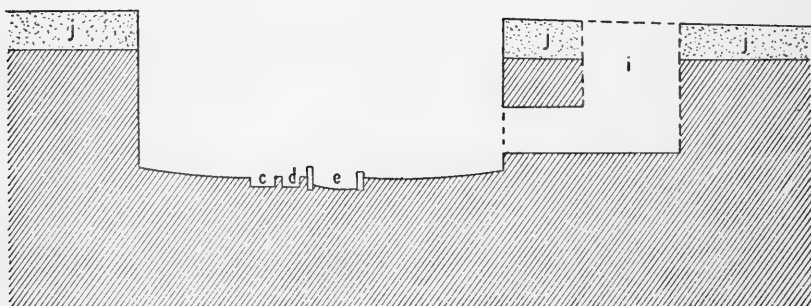
FIGURE 20.—Structure 11. *a*, holes for main support posts; *b*, stone in compartment wall; *c* and *d*, holes in floor in position of sipapu; *e*, fire pit; *f*, stone in compartment wall; *g*, storage basin; *h*, stone mold; *i*, ventilator shaft; *j*, accumulation of sand above original surface.

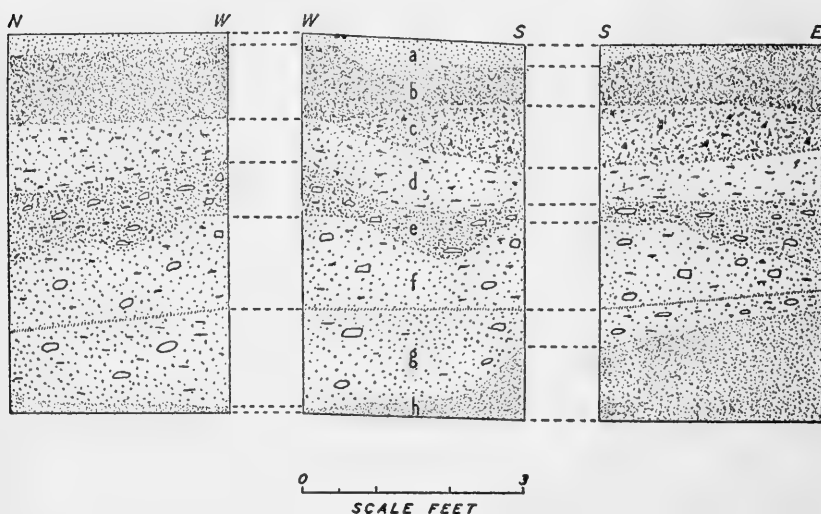
FIGURE 22.—Test pillar from fill in structure 10. N, W, S, and E, indicate north, west, south, and east corners.

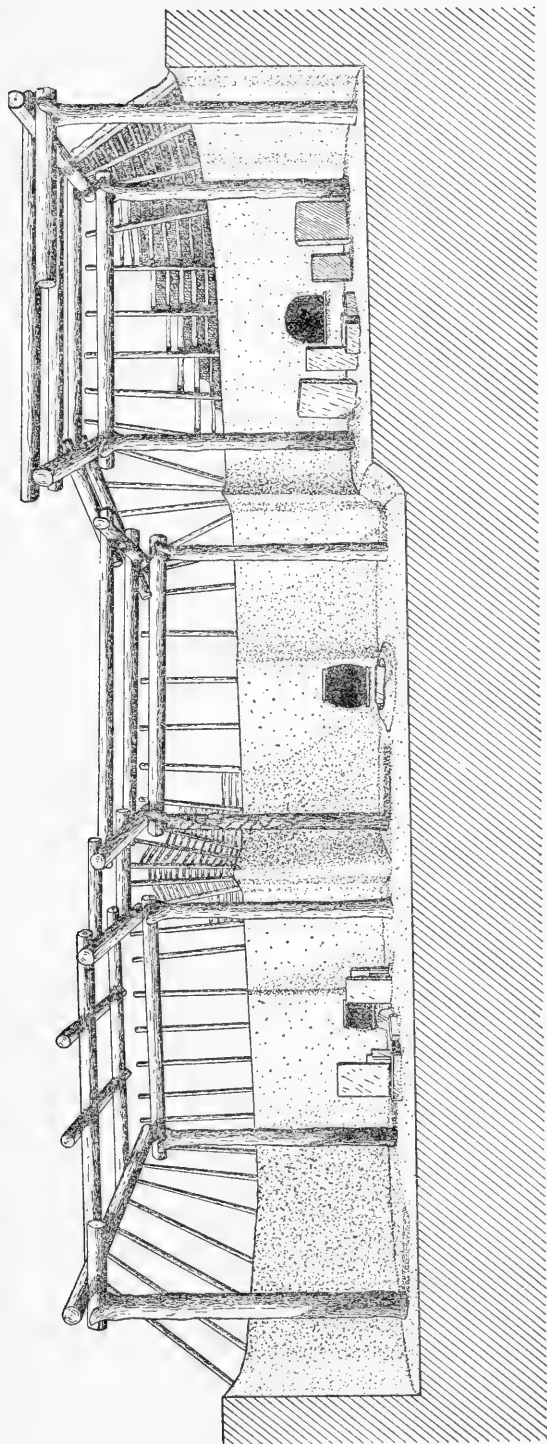
FIGURE 23.—Postulated reconstruction of timber arrangement in superstructure erected over pits 9, 10, and 11. Some of main support posts omitted at front of drawing to show construction more clearly.

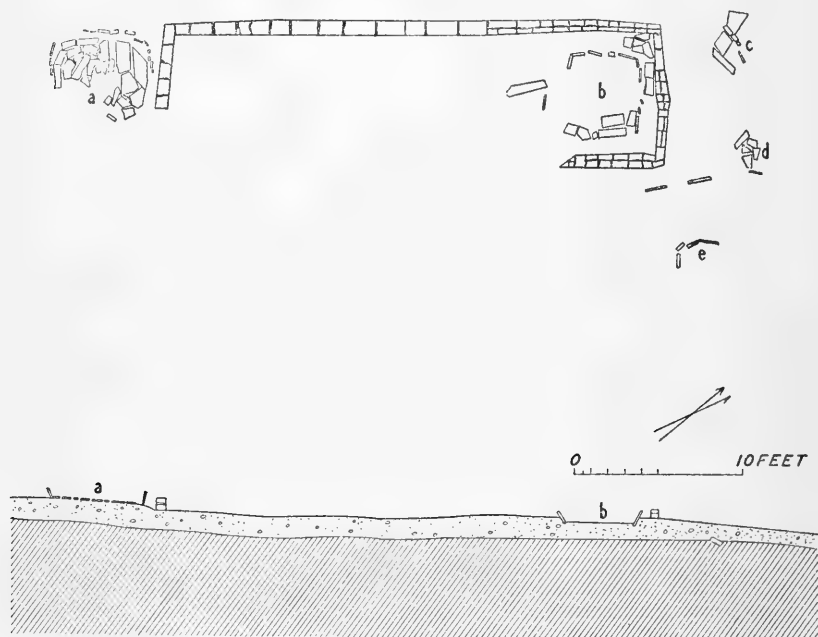
FIGURE 24.—Surface remains B in first group. Granary pits at *a*, *b*, *c*, and *d*; exterior fire pit at *e*.

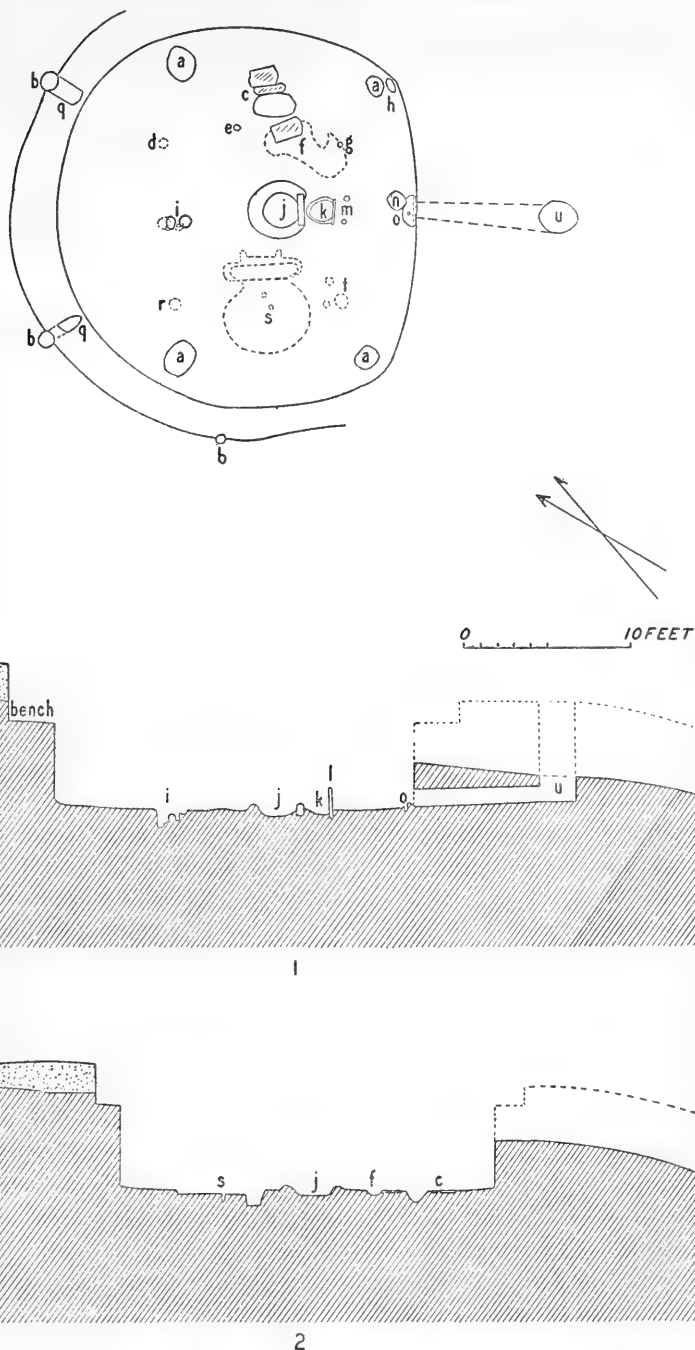
FIGURE 26.—Structure 12. *a*, holes for main support posts; *b*, secondary supports at back of bench; *c*, paving on floor; *d*, plastered-over hole in floor; *e*, storage hole; *f*, plastered-over basin; *g*, storage hole in floor; *h*, storage basin; *i*, sipapu holes; *j*, fire pit; *k*, ash pit; *l*, deflector; *m*, ends of ladder poles; *n*, cover stone for ventilator; *o*, shelf for cover stone and hole for small post to hold stone; *q*, plaster ridges on bench; *r*, plastered over hole; *s*, plastered over basin suggestive of subfloor kiva vault; *t*, plastered-over holes; *u*, ventilator shaft; *v*, sand accumulation.

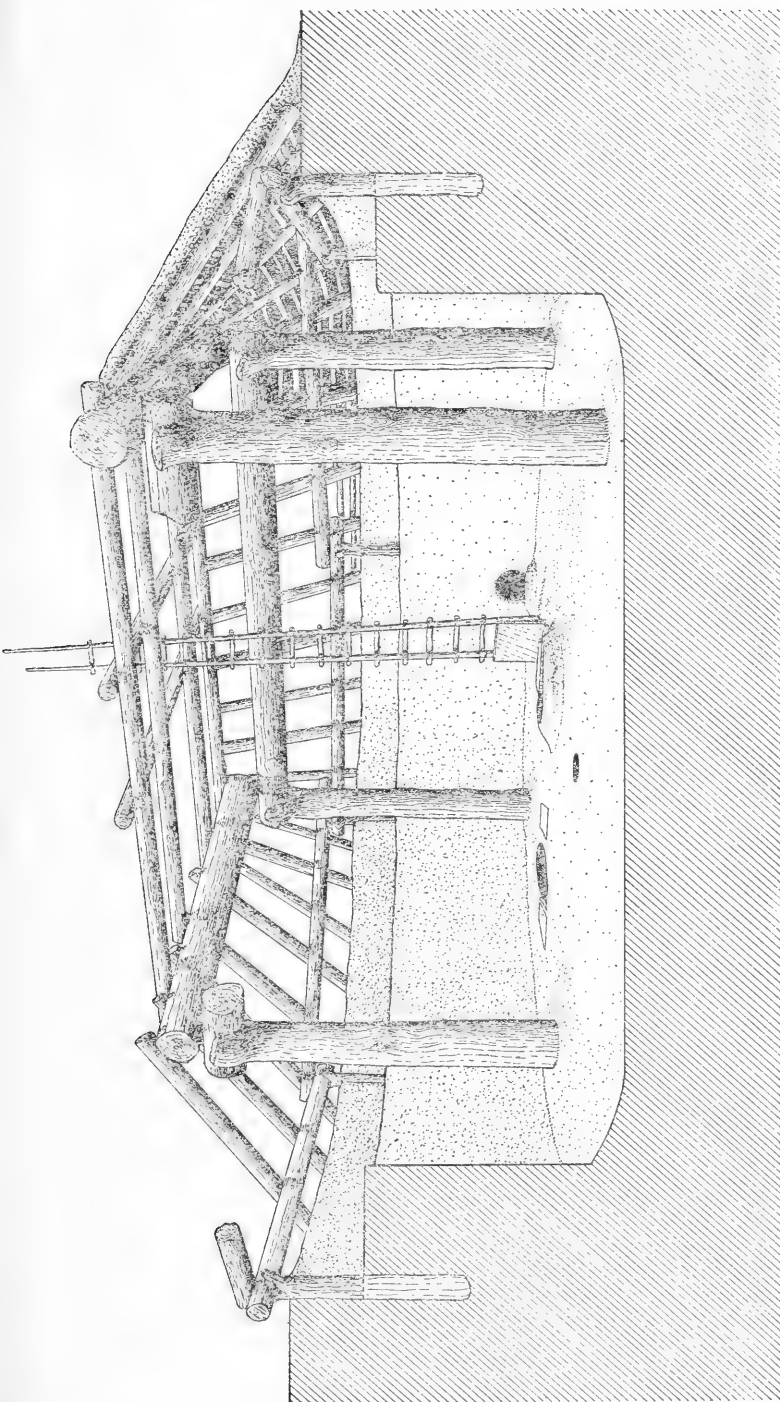
FIGURE 28.—Postulated reconstruction of superstructure erected over structure 12. Some of front timbers omitted from drawing so as not to complicate the diagram.

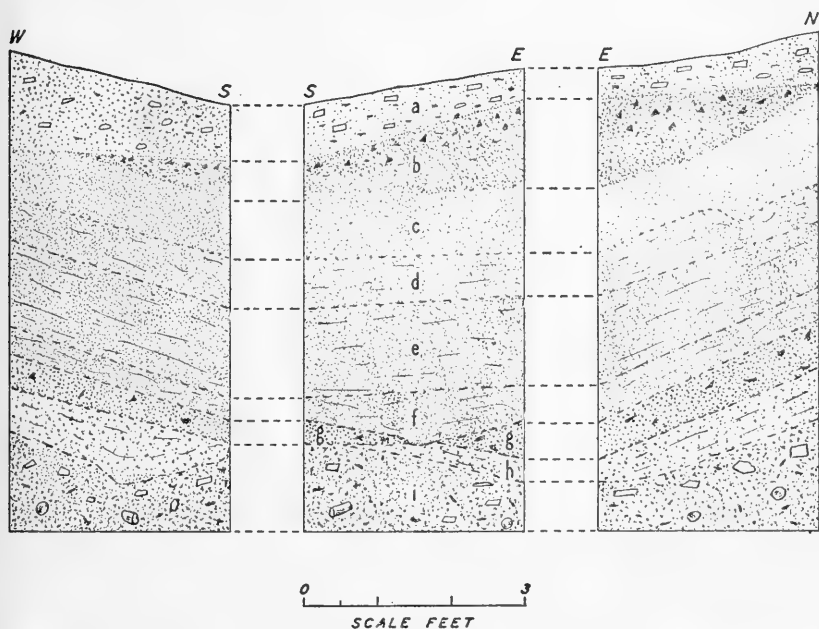
FIGURE 29.—Pillar left from fill in structure 12. E, W, N, and S indicate east, west, north, and south corners.

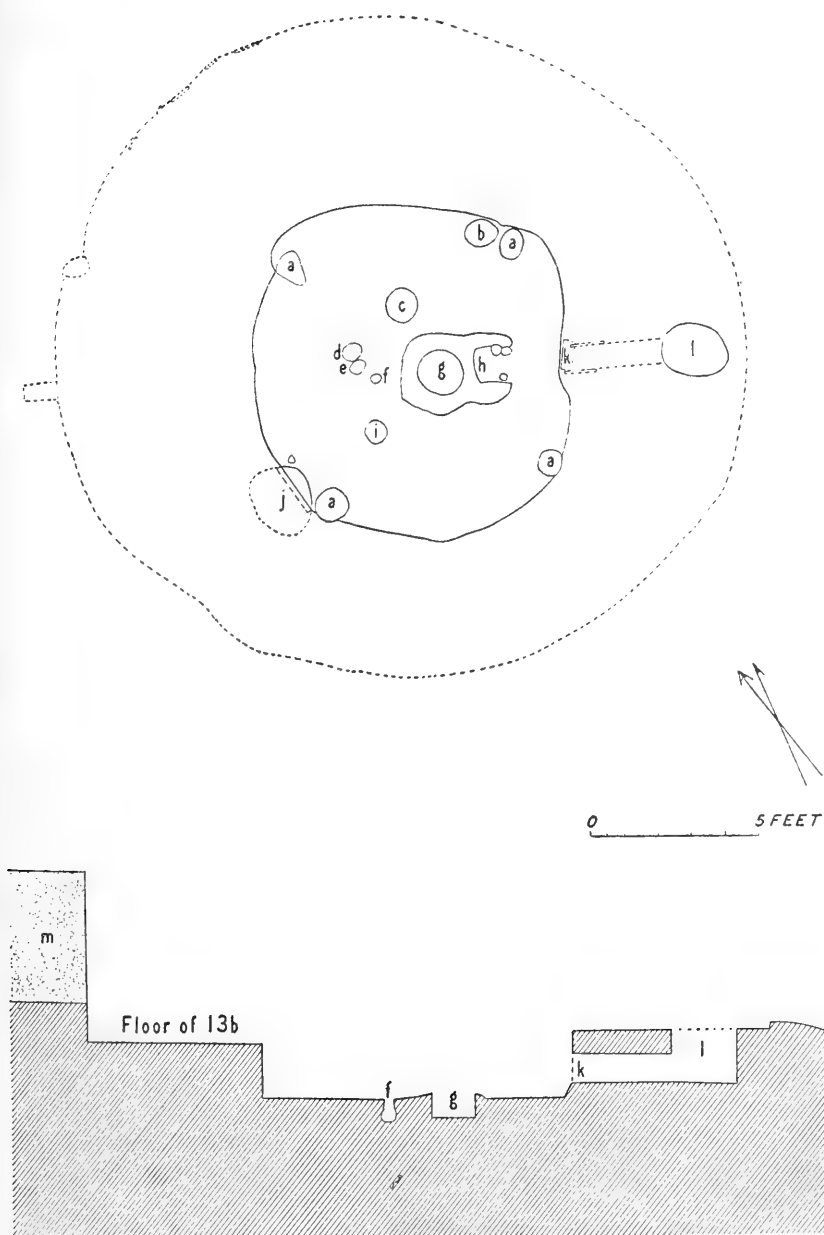
FIGURE 30.—Structure 13a. *a*, holes for superstructure support posts; *b*, *c*, *d*, and *e*, storage holes; *f*, sipapu; *g*, fire pit; *h*, ladder box; *i*, storage basin; *j*, storage pocket in wall; *k*, ventilator opening in chamber; *l*, ventilator shaft; *m*, accumulated sand. Dotted lines indicate position of 13b.

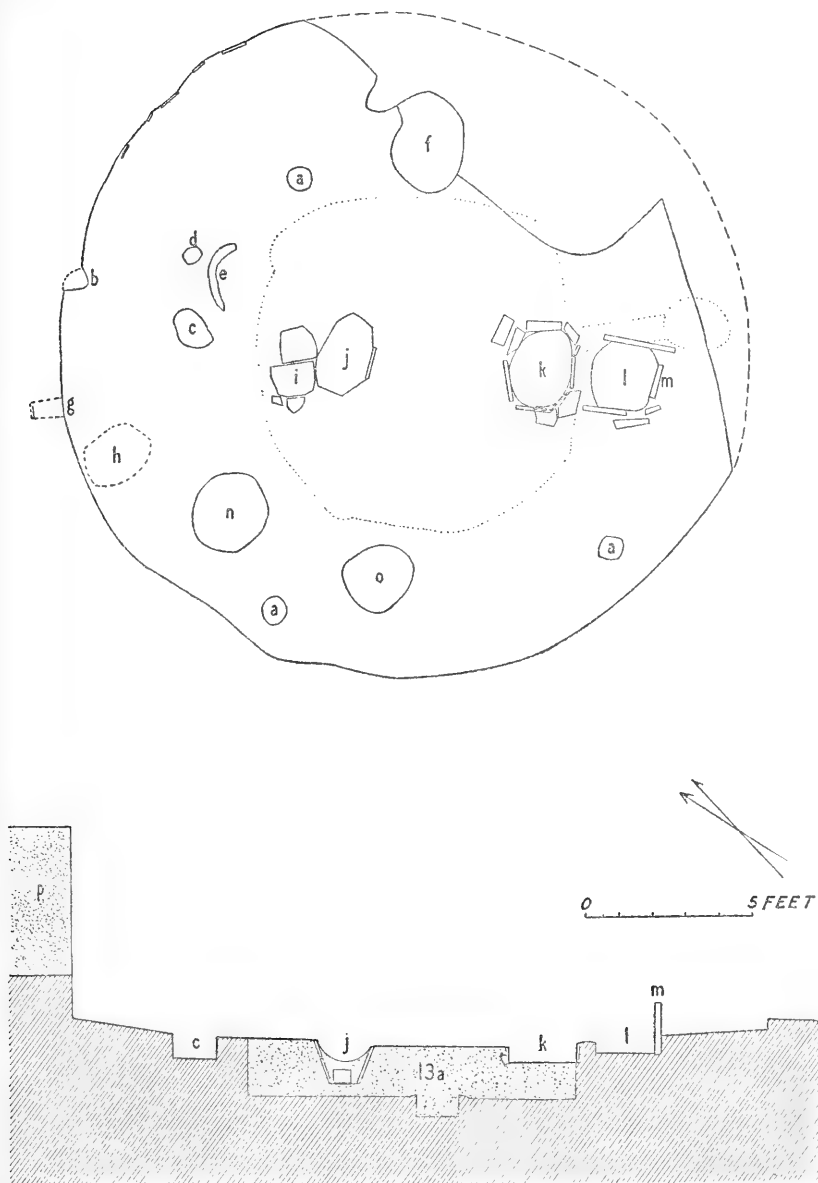
FIGURE 31.—Structure 13b. *a*, holes for main support posts; *b*, beam placement; *c* and *d*, storage holes; *e*, groove in floor; *f*, storage basin; *g*, wall pocket or Katchina niche; *h*, basin covered by floor plaster; *i*, stones embedded in floor; *j*, basin in floor; *k*, fire pit; *l*, ladder box; *m*, deflector stone; *n* and *o*, storage basins; *p*, drift sand. Dotted lines show position of 13a.

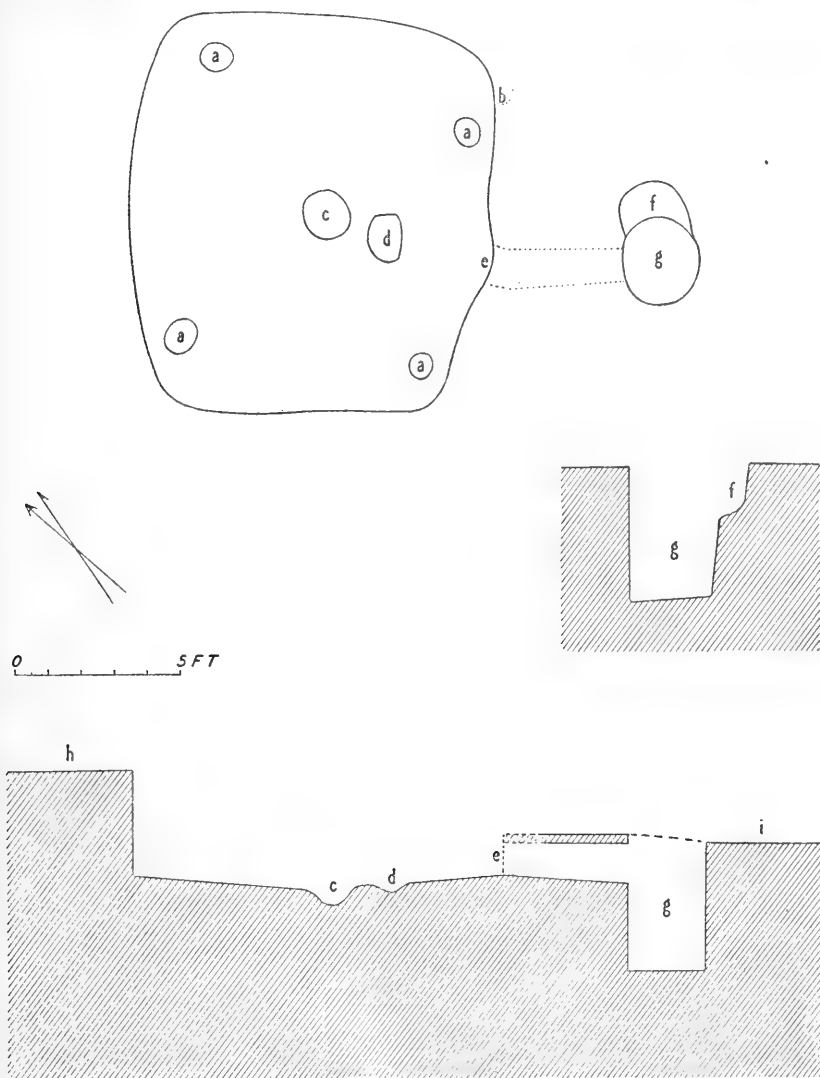
FIGURE 32.—Structure 14. *a*, holes for main support posts; *b*, wall pocket; *c*, fire pit; *d*, ladder box; *e*, ventilator opening; *f* and *g*, exterior opening to ventilator shaft; *h*, platform of dance court dais; *i*, floor of dance court.

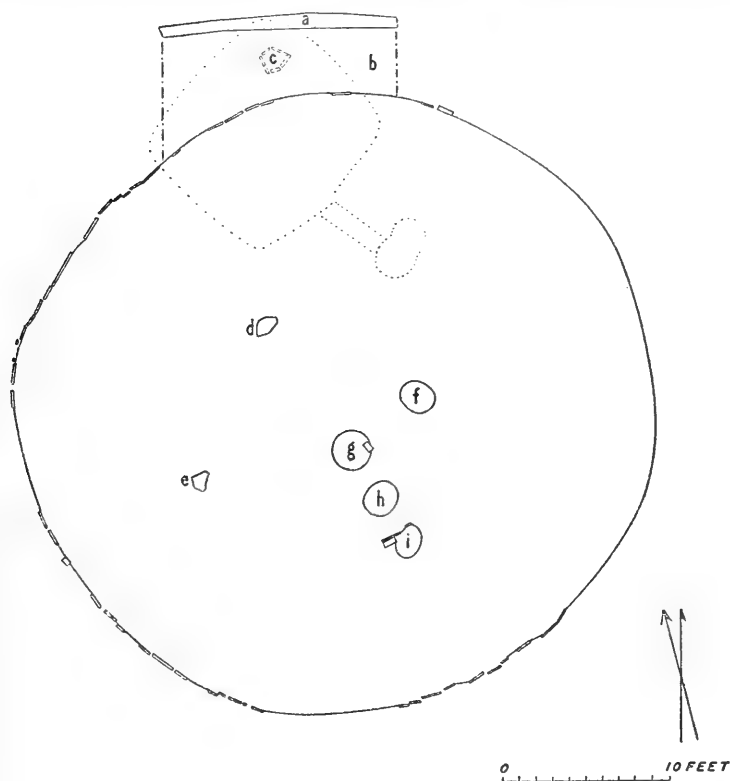
FIGURE 33.—Dance court. *a*, masonry wall; *b*, dais; *c*, fire pit; *d* and *c*, stones embedded in floor; *f*, basin in floor; *g*, fire pit; *h*, ash pit; *i*, basin in floor. Dotted lines show location of structure 14.
